# MAINTENANCE BULLETIN

NO. 159  
AUGUST 1998

## ALFA COMPANY

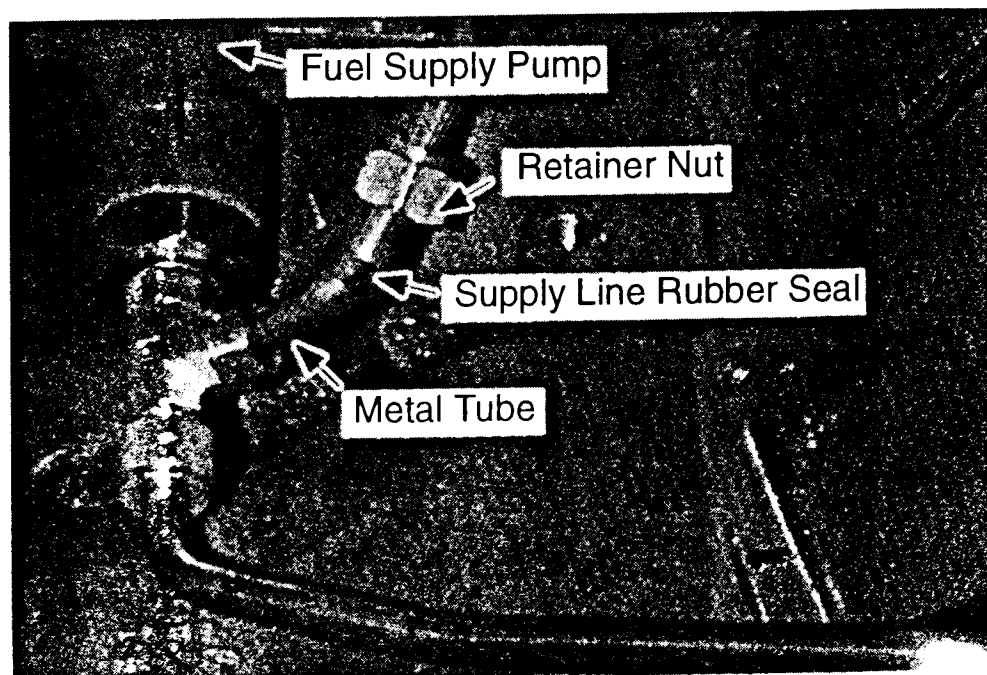
Figure 2A. – Regulator Valve Fuel Supply Fitting At Three-Way Fitting

**A loss of power** sometimes accompanied by a knocking sound can be caused by fuel restriction to the cylinder head on subject engines. The fuel supply fitting in the cylinder heads (right rear and left front) has an orifice that can become restricted, usually debris from the supply line rubber seal (**See Figure 2**). Diagnosing the engine for this condition may generate multiple cylinder contribution codes on one bank.
